## PROJECT SUMMARY

### Raytown Fire Station

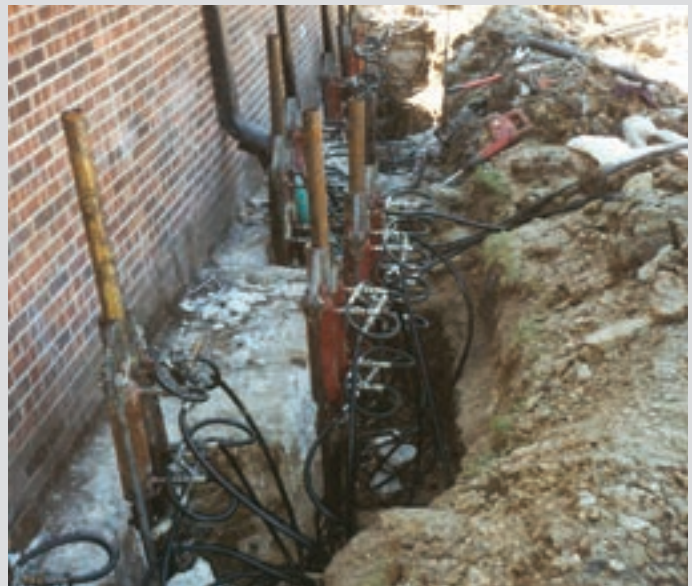
**Project Description:** The north wall of the Fire Station began to show signs of distress shortly after contaminated soils and underground fuel storage tanks were removed directly north of the foundation wall. The foundation settled vertically, approximately 4 inches and also rotated laterally causing severe masonry cracks and two roll up exit doors to no longer function.

**Design Details:** Power Lift installed 36 driven steel piles to raise and support the north wall. The hydraulically driven steel piles were specified over other repair methods due to the ease of installation, non-disruption to the station's operation, and the ability to seat them into the underlying rock formation 18 to 20 feet below grade.
