Owner: Texas A&M University | General Contractor: Alpha Building Corp.
Chris Jennings (979) 846-0100 | EOR: Cutler-Gallaway Services, Inc.
Earl Cutler (210) 496-3326 | Completion Date: September, 2004
Contract Amount: \$194,960.00 | Maximum Column Load: 384 kips

PROJECT SUMMARY

Renovations To TAMU BLDG. #457

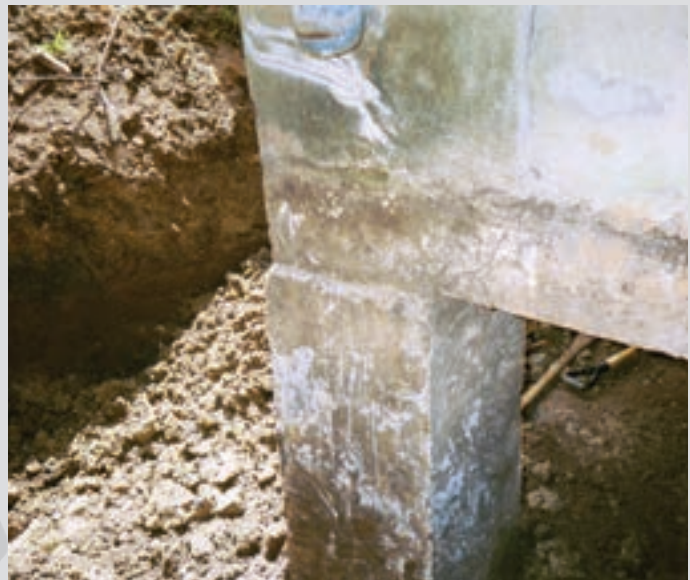
Project Description: This concrete framed building was built in 1934 as the original Animal Husbandry building on the campus of Texas A&M University. Founded on spot footings 10' - 12' below grade vertical columns supported the grade beams which were also isolated from the soil. The footings ranged in size from 6' x 6' to 8' - 6' x 8' - 6". The columns ranged from 18" x 24" to 30" x 30". With time, the building was converted to offices and remodeled. Throughout the years, settlement progressed causing cracks throughout the building to the point that remediation was required.

Subsurface Conditions: Highly plastic clays were present to depths of more than 30' to the underlying rock formation. Testing revealed the soils were very

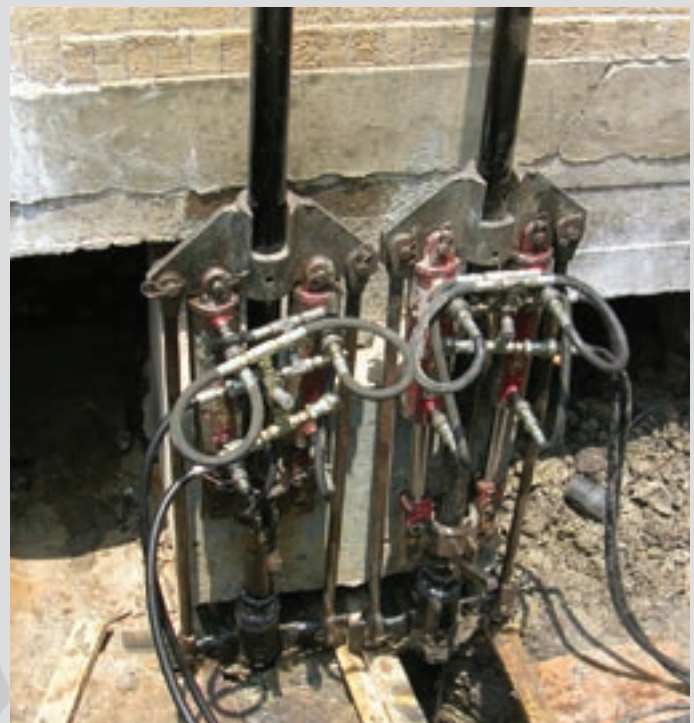
desiccated to depths beyond the footing depths. As the site was covered with mature Live Oak trees, it was clear the moisture removal by the trees had brought on significant long-term soil shrinkage, causing settlement of the footings.

From early on, it was clear the high column loads would be the greatest challenge of the project. This was compounded by the fact the top of the footings were 8' - 10' below grade. Power Lift worked closely

Design Details: As the college did not wish to remove the trees, a deep foundation system was needed. When contacted to evaluate the problem, Power Lift recommended the engineering services of Cutler-Galloway be retained. CGS, Inc. was recommended due to their vast experience in designing remedial foundation solutions, intimate knowledge of the local soil conditions, construction methods utilized in the area, and their unsurpassed reputation for quality, integrity, and attention to detail.
