## PROJECT SUMMARY

### Butler County Community College

**Project Description:** The concrete slab floor of the college had settled  $\pm 1-1/2"$  causing offset areas in the floors, which posed tripping hazards. Also, numerous doors to classrooms and offices would not function properly.

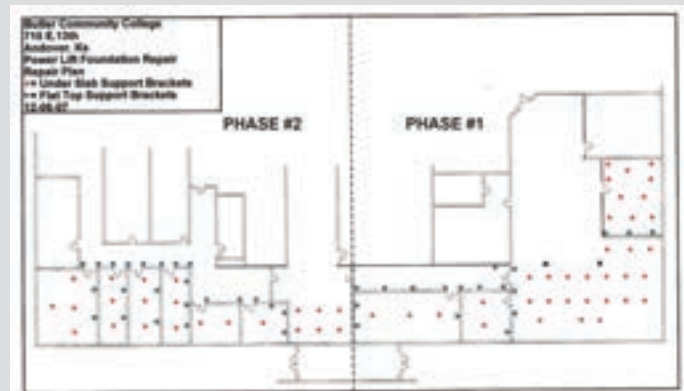
A geotechnical firm performed tests on the underlying soils and found the soils to be saturated from poor drainage conditions and a leak in the sanitary sewer system.

**Design Details:** The Power Lift system was chosen over other methods because of its ability to synchronously and uniformly lift 98 piles at one time. Also, the crew met a 3 week time restriction required by the owner. To meet the dead line and not interrupt school activities, the project was broken down into two phases. Power Lift started with Phase 1 and then moved on to Phase 2 installing a total of 41 slab piles and 58 under wall piles. Complete elevation loss was restored during the lift and the project was completed within the owner's time frame.

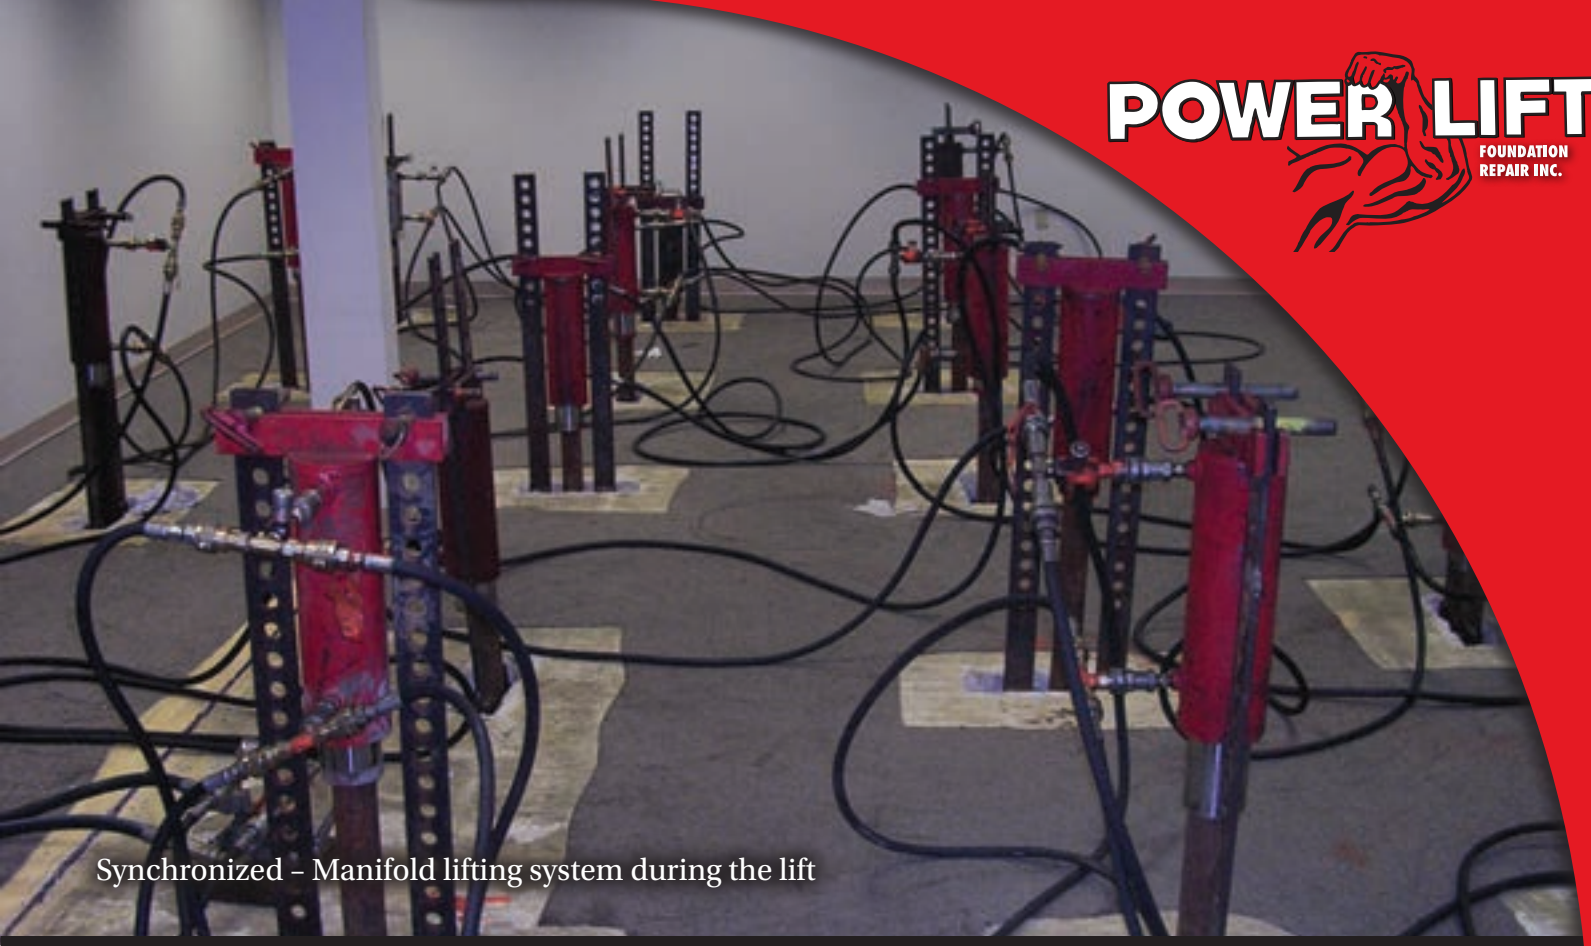
Synchronized – Manifold lifting system during the lift

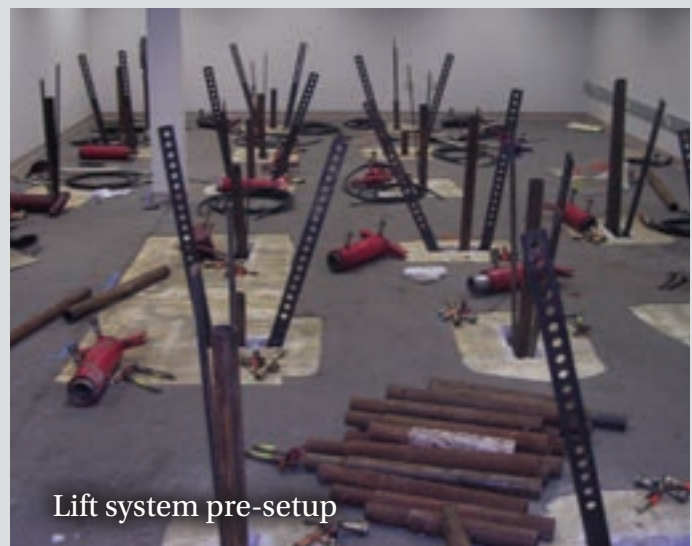
Lift system pre-setup
