PROJECT SUMMARY

Peoples Bank of Nixa

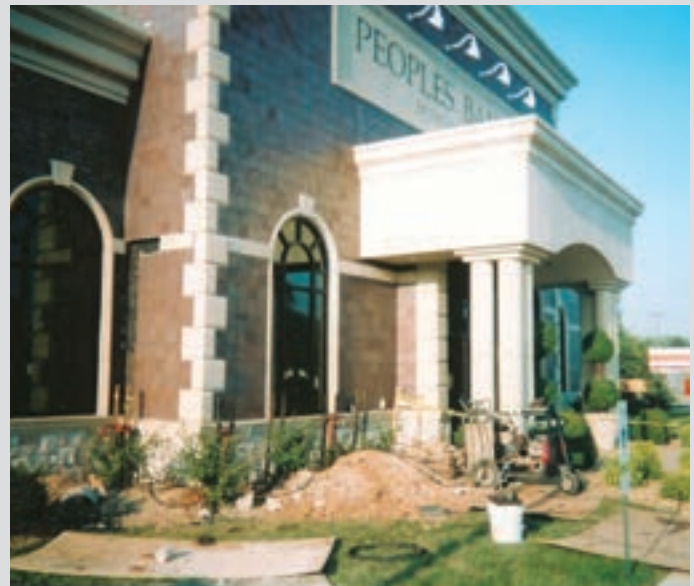
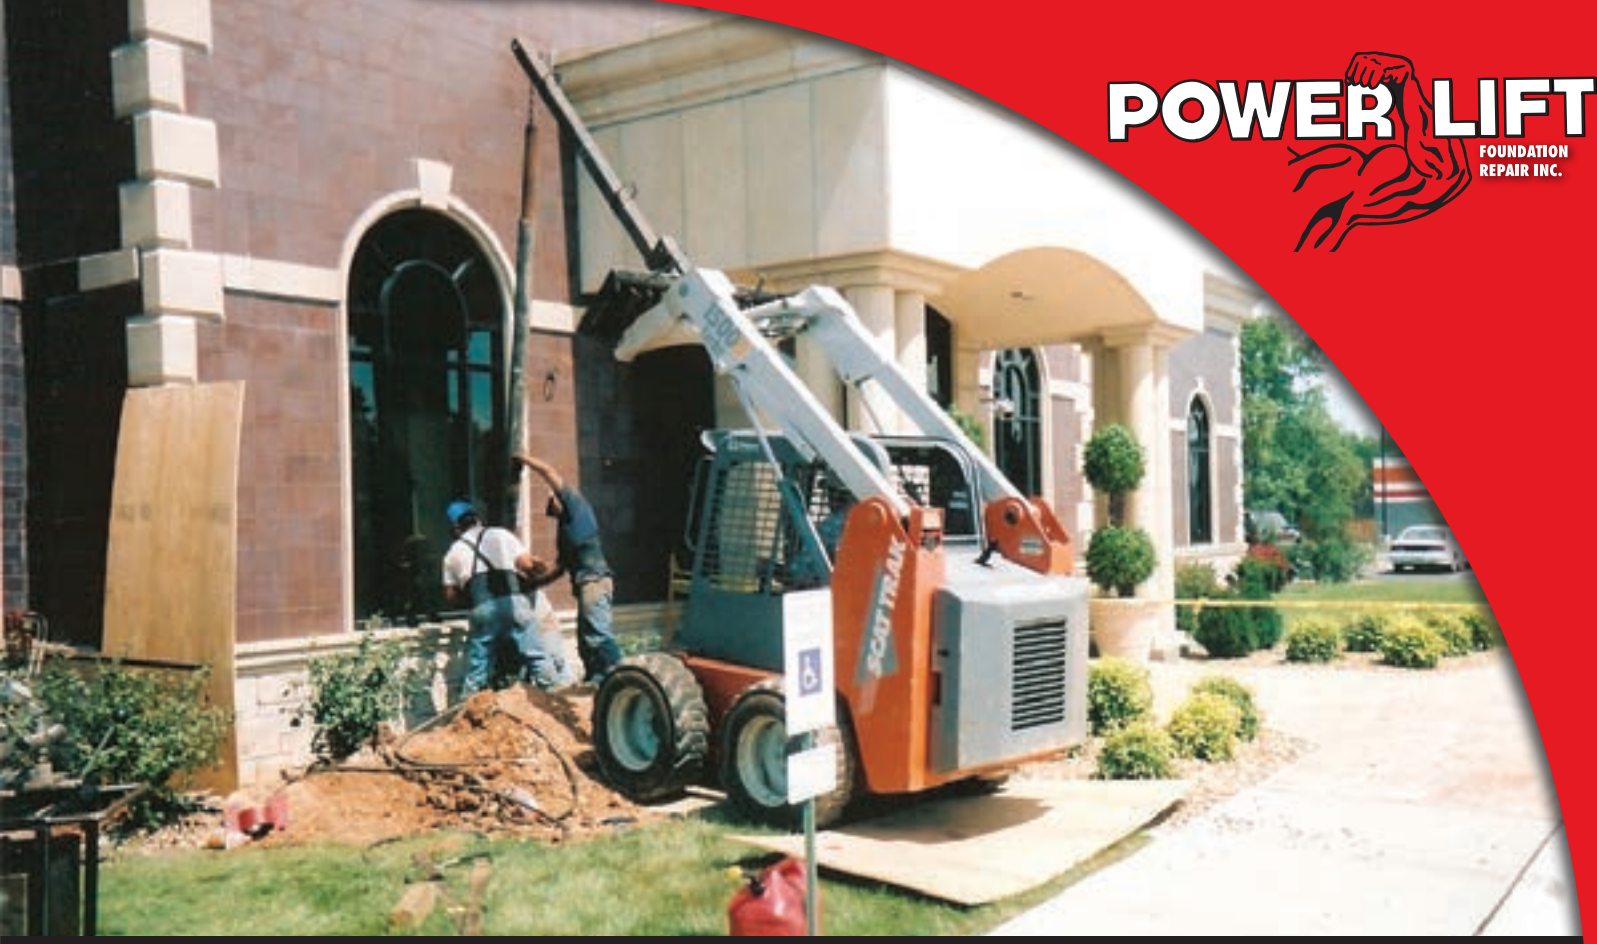
Project Description: At the time of the building's original construction, the basement was over excavated to allow forming of the basement walls. The entrance, which did not bear on the basement, was constructed on poorly compacted basement backfill. Shortly after completion of the building, the corner of the entrance settled approximately 1-1/4 inches, causing exterior cracks and the slab floor to slope.
