PROJECT SUMMARY

Ruston Furnance –St. Gobain Containers

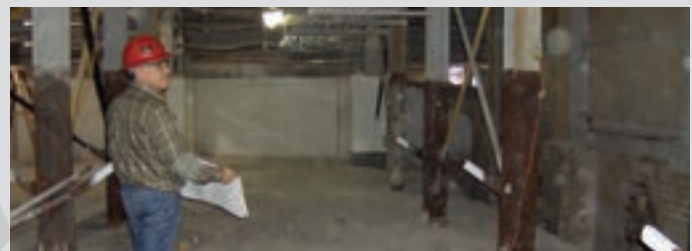
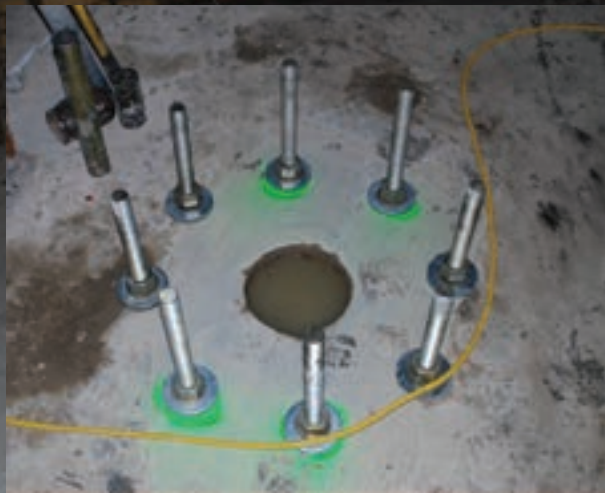
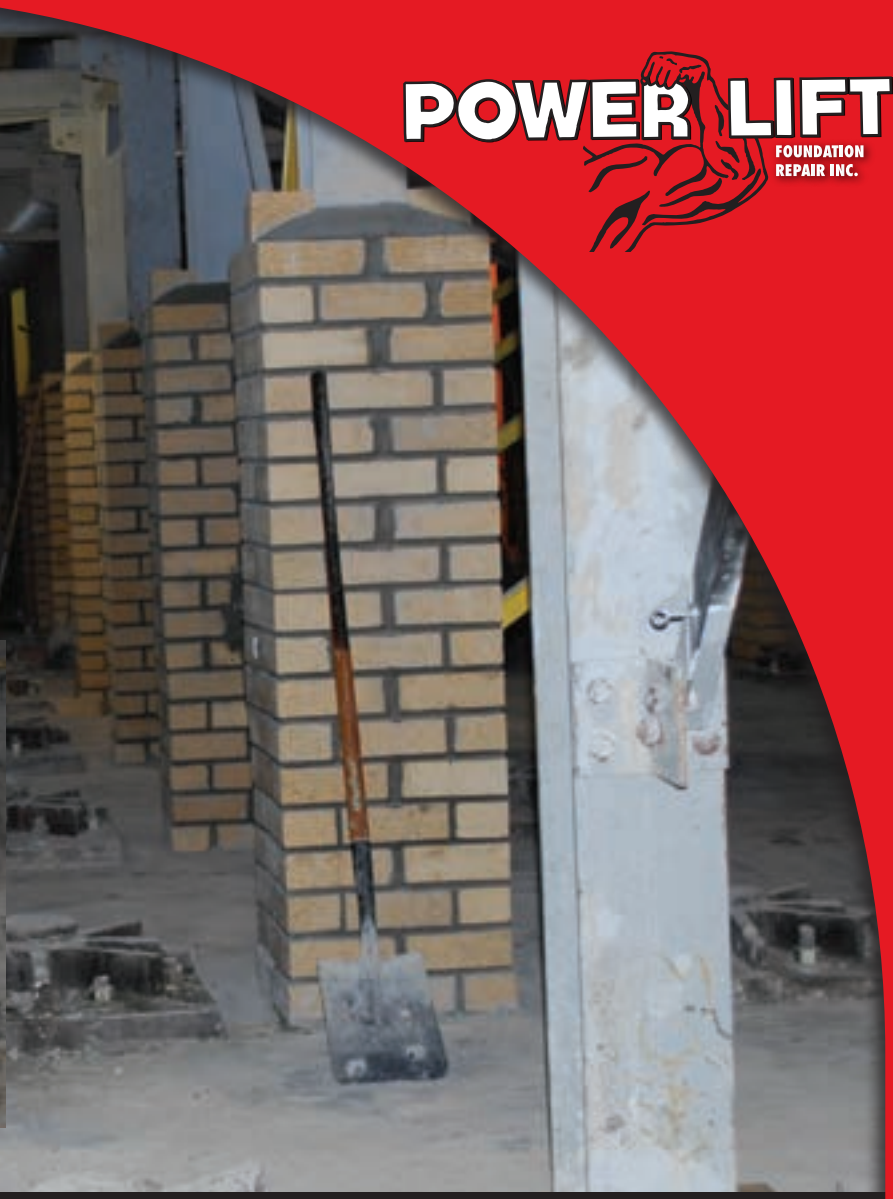
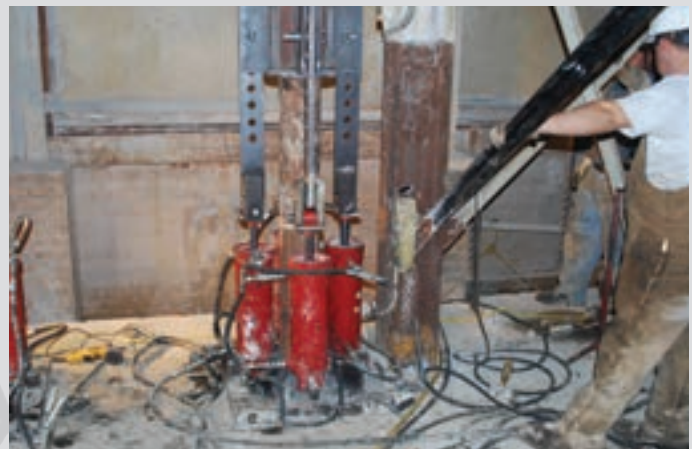
Project Description: The St. Gobain Containers facility in Ruston, LA was established in the 1950's. In 1965, an additional furnace was added to increase production. Furnace #2 was supported on a 3' thick conventionally reinforced mat foundation. The furnace and foundation weighed in excess of 2-1/2 million pounds. Movement of the furnace had been observed for some time, but accelerated in the months leading up to repair.

samples revealed water temperature of more than 100 degrees. Furthermore, the upper 10' of the soil mass was found to be saturated. As large volumes of water were utilized in the manufacturing process, it was determined that leakage of below-grade drainage systems had allowed water infiltration into the soil mass reducing the soil's capacity, thus prompting

settlement of the mat foundation.

Design Details: Due to the lack of access below the furnace and low overhead clearance, repair methods were very limited. This was compounded by the massive loads present to be re-supported. Bryan Smith, P.E., called upon Power Lift for repair recommendations. After considering the situation, driven steel piles were the selected repair option. 7" diameter .408 wall steel piles were advanced 30' below grade and founded in the shale formation. Specially designed anchorage assemblies were manufactured and installed by Power Lift to transmit the load of the mat and furnace onto the piles. The piles were installed in sections 8' in length and connected with full penetration welds. The piles were jacked to an ultimate capacity of 320 kips. After the piles were installed to the proper depth and capacity,

the mat elevation was adjusted and secured to the anchorage assembly via welding the piles to the anchor plates. The site was fully restored and returned to operation while the plant was shut down between Christmas and New Year, with construction taking only 7 days to complete.
