Owner: Texas A&M University | General Contractor: Alpha Building Corp.
Chris Jennings (979) 846-0100 | EOR: Cutler-Gallaway Services, Inc.
Earl Cutler (210) 496-3326 | Completion Date: September, 2004
Contract Amount: \$194,960.00 | Maximum Column Load: 384 kips

PROJECT SUMMARY

Renovations To TAMU BLDG. #457

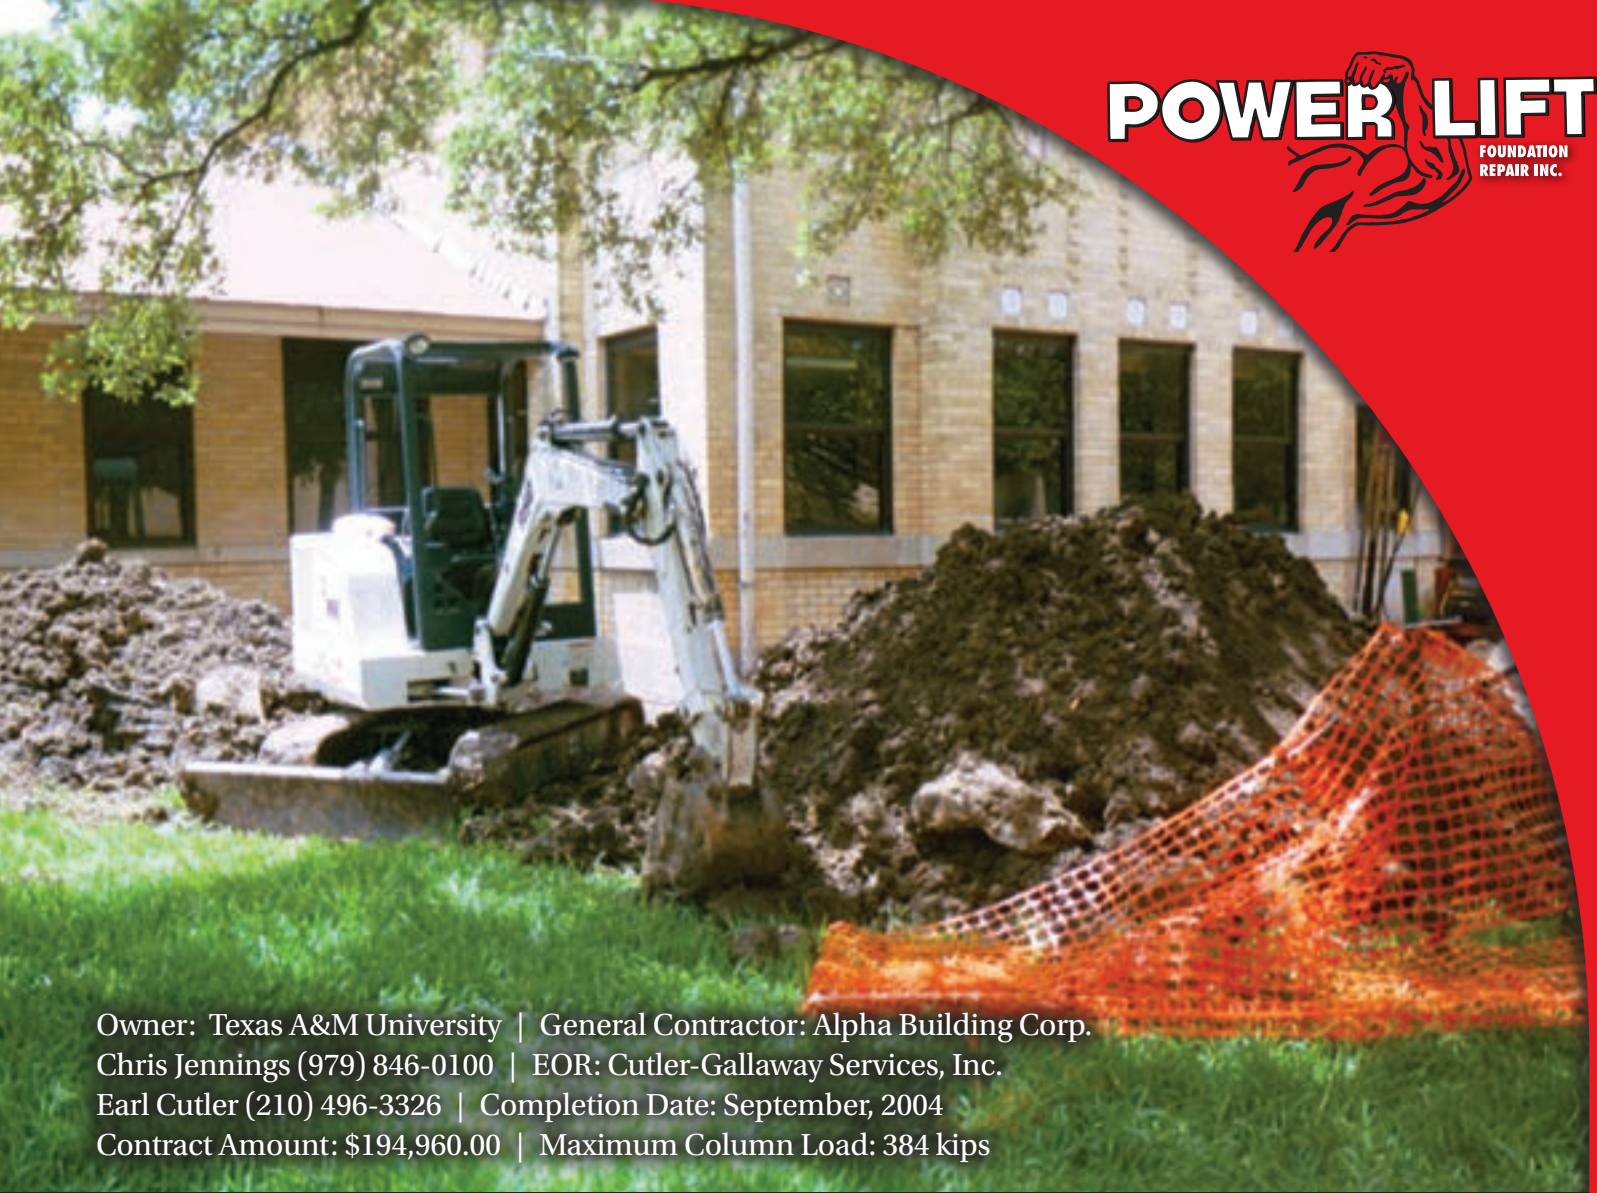
Project Description: This concrete framed building was built in 1934 as the original Animal Husbandry building on the campus of Texas A&M University. Founded on spot footings 10' - 12' below grade vertical columns supported the grade beams which were also isolated from the soil. The footings ranged in size from 6' x 6' to 8' - 6' x 8' - 6". The columns ranged from 18" x 24" to 30" x 30". With time, the building was converted to offices and remodeled. Throughout the years, settlement progressed causing cracks throughout the building to the point that remediation was required.

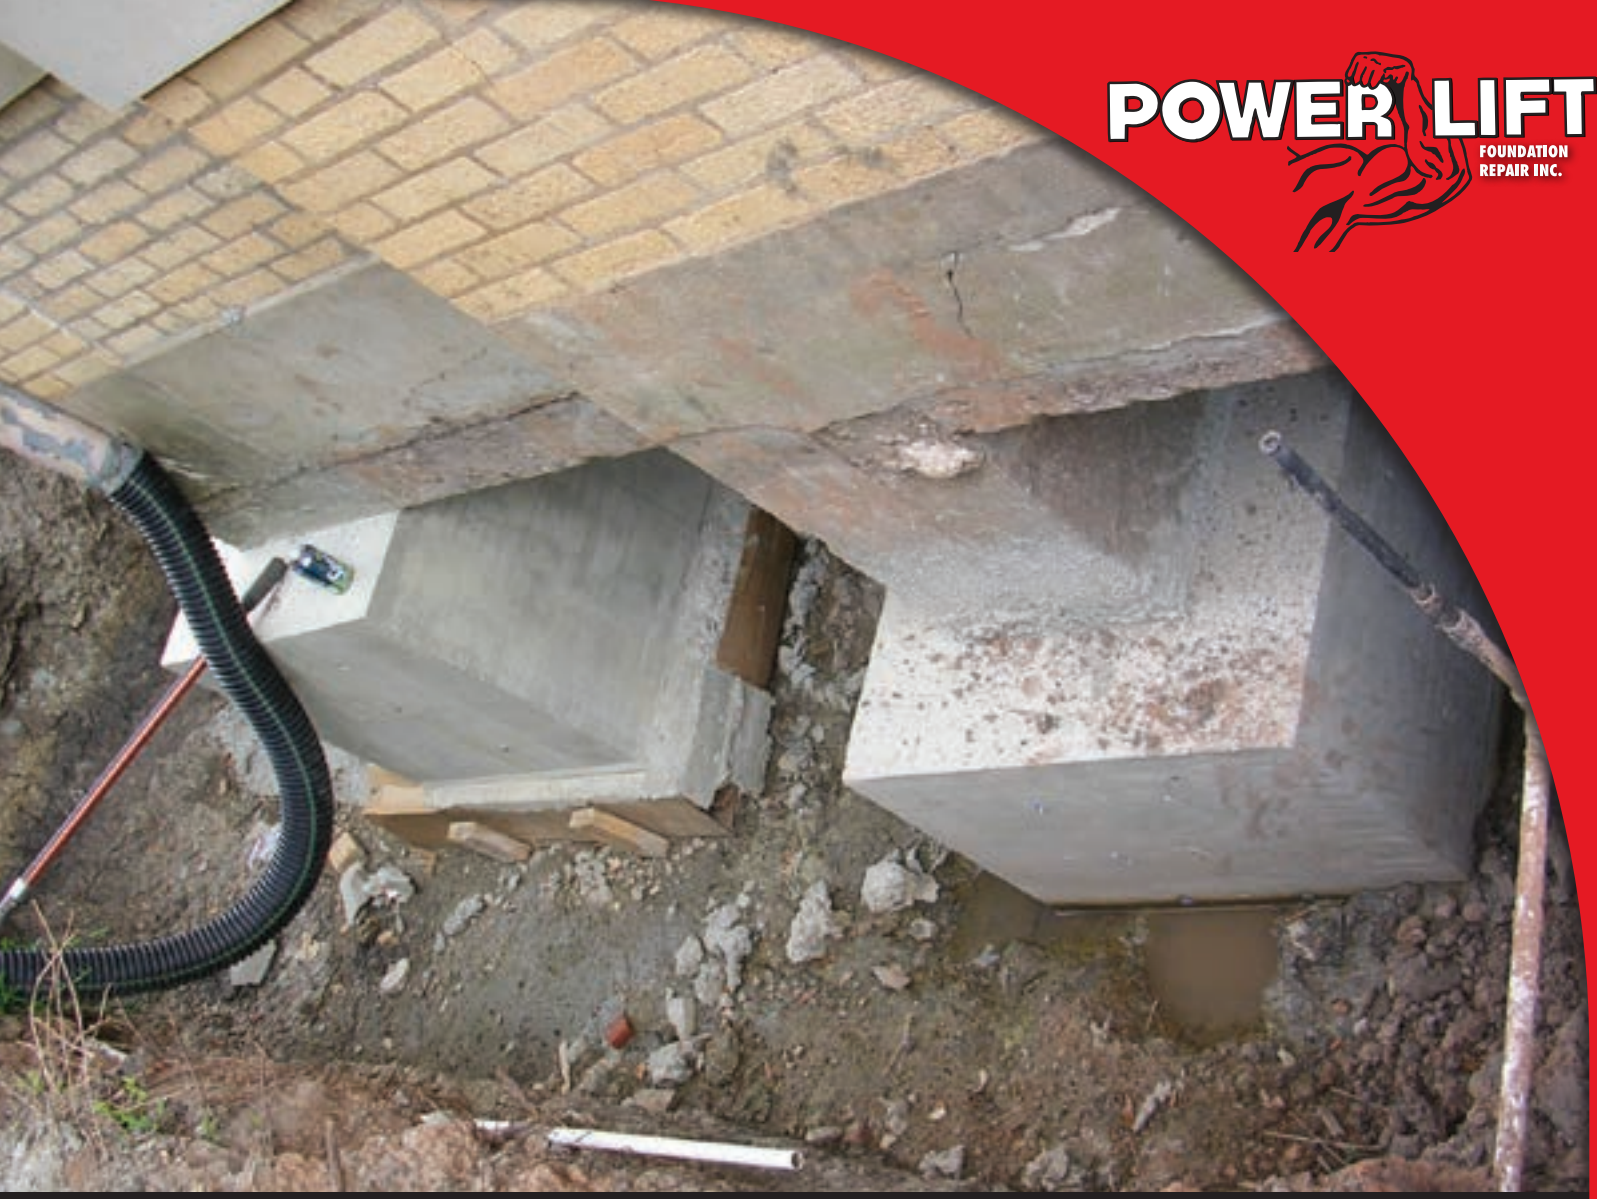
desiccated to depths beyond the footing depths. As the site was covered with mature Live Oak trees, it was clear the moisture removal by the trees had brought on significant long-term soil shrinkage, causing settlement of the footings.

Design Details: As the college did not wish to remove the trees, a deep foundation system was needed. When contacted to evaluate the problem, Power Lift recommended the engineering services of Cutler-Galloway be retained. CGS, Inc. was recommended due to their vast experience in designing remedial foundation solutions, intimate knowledge of the local soil conditions, construction methods utilized in the area, and their unsurpassed reputation for quality, integrity, and attention to detail.
