Engineer: Residential Structural Inspection PE (316) 686-9876

PROJECT SUMMARY **United Instruments, Inc.**

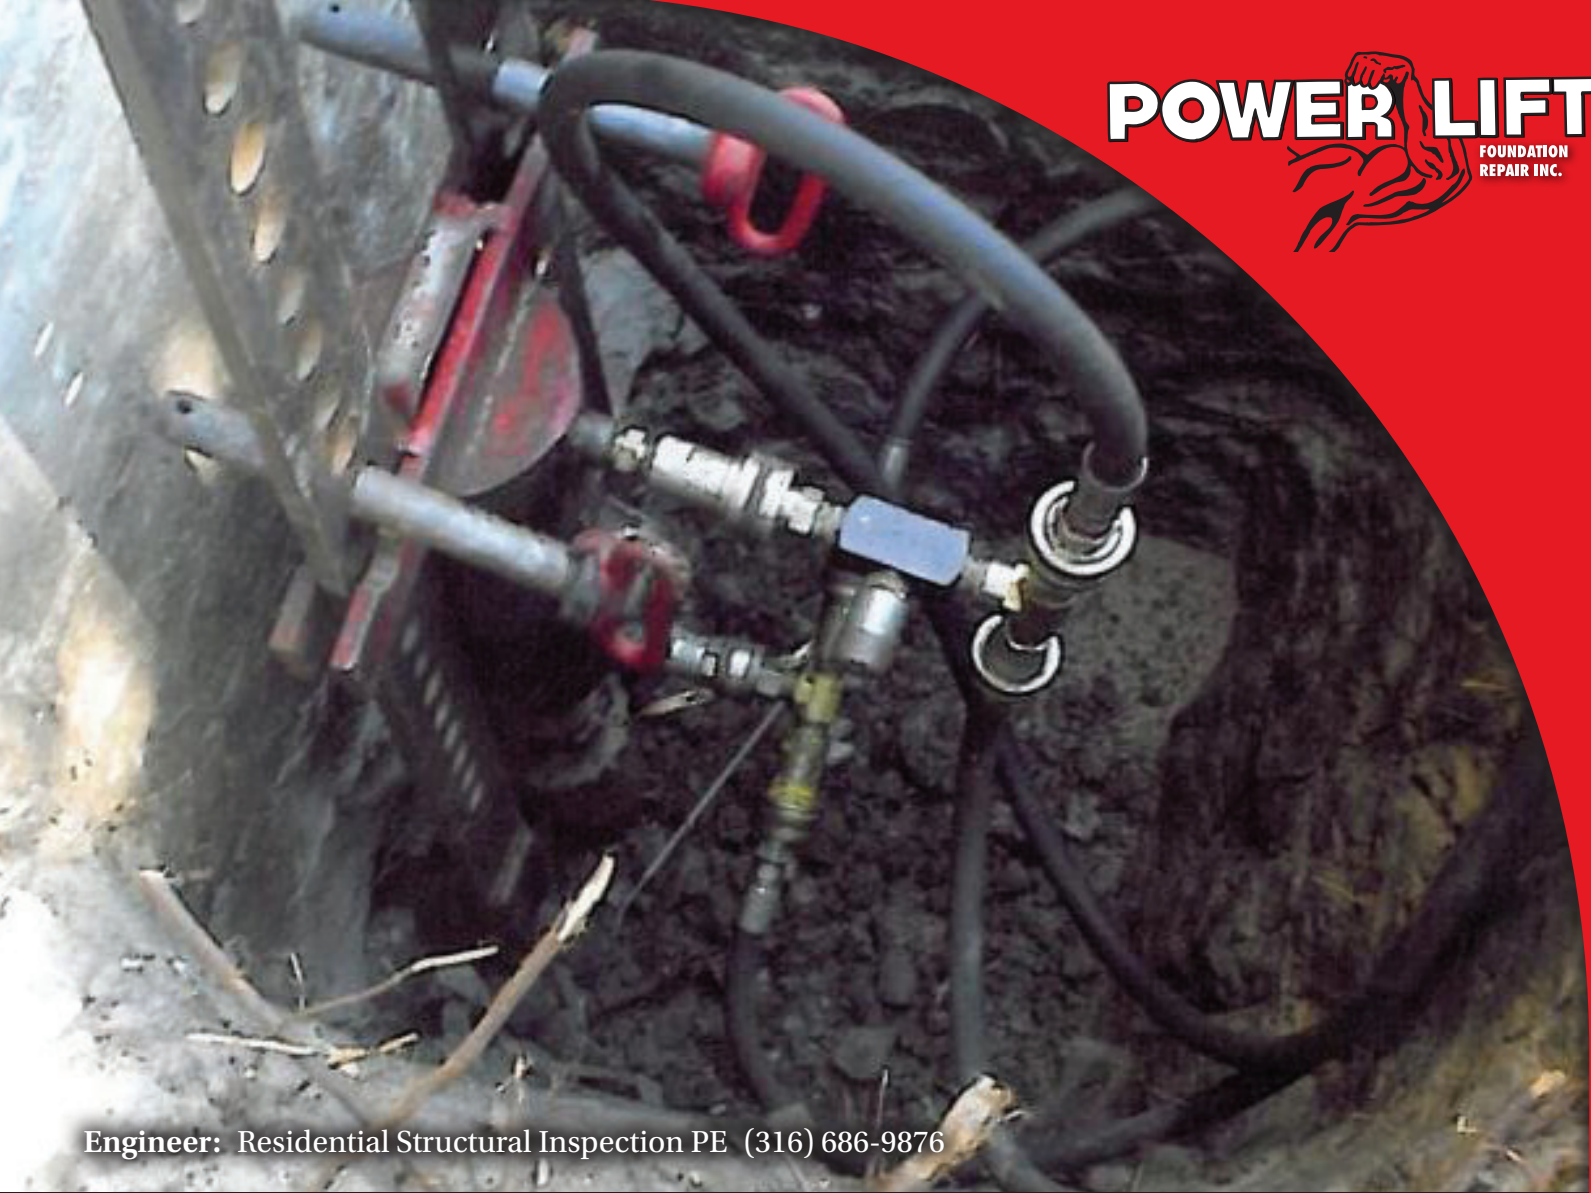
Project Description: The Southwest corner of this two-story office had settled approximately 1". The settlement was due to poor surface drainage conditions and water infiltration from a settled sidewalk adjacent to the building, which was allowing water to stand and migrate under the building. The settlement had also caused the concrete floor adjacent to the wall to settle and crack.

Design Details: Power Lift worked with engineers to design a repair plan for the lift and stabilization of the perimeter foundation. Eight steel piles were installed on the south perimeter wall and a pile was installed on both sides of the passage door on the west side. Twelve interior slab support piles were also installed to lift and support the floor slab. Using

the synchronized Power Lift system, the perimeter foundation and slab were both raised back to their original position. After the slab was lifted and re-supported the void between the slab and soil was filled by mudjacking to assure the slab was fully re-supported.
