Owner: Santa Fe Ranch LTD.

## PROJECT SUMMARY

### Santa Fe Ranch

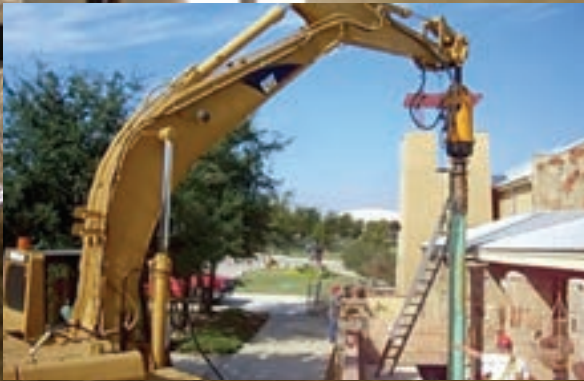
As the structure was built into a hillside with a deepened foundation on the downhill side, it was decided to underpin the west wall of the structure, remove a section of the west deepened foundation, and begin excavation eastward beneath the building. As the excavation progressed, shoring was erected beneath the structure for safety. As underpinning locations were exposed, driven steel piles were advanced through the unstable soil and seated in the shale at 45' below grade. Each pile was jacked to 100 kips installation capacity. The piles were comprised of multiple segments of 3", 3 ½",

4 ½", and 5 ½" diameter pile material. Once excavation was complete and all piles had been installed, Power Lift's synchronized lifting system was utilized to lower the building more than 12". The piles were welded to the pile heads and secured permanently in place supporting the structure. Voids were established around the entire perimeter of the structure's foundation and void retainers installed around the exterior to prevent soil intrusion. Steel bracing was installed to provide lateral stability to the pile system. To anchor the building in place, two 36" diameter drilled shafts (one on each side of the building) were installed by Power Lift personnel and socketed into the shale to a depth of 55' below grade. The shafts were equipped with a pile cap that was doweled and anchored into the building to further stabilize the building against lateral movement. To restrain earth
