PROJECT SUMMARY

Mid Continent Public Library, Gladstone, MO

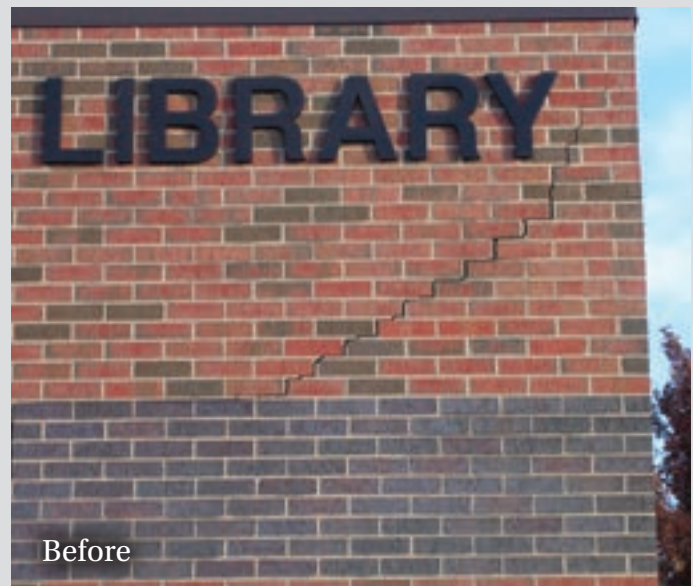
Project Description: At the beginning of the summer of 2006, maintenance crews for Mid Continent Public Library started getting reports of minor cracking of the interior walls at the North Antioch Branch Library. An engineering firm was hired to monitor the movement and determine the proper repair. During the course of their investigation, the settlement magnified in a matter of weeks. The southeast corner and entire south wall settled approximately 1 1/2" causing cracks in the interior block and exterior brick.

Design Details: Power Lift installed 32 driven steel piles to raise and support the southeast corner and south wall to halt the ongoing settlement. Power Lift's steel pile concept was chosen for its strength

capacity and for its patented unified lift system. During the design phase of the project, Power Lift discovered that the footing extended 3' from the stem wall and was 16" thick. To minimize the damage of pile installation to the footing system, Power Lift saw cut the footing at each pile location to allow the bracket to be set directly under the stem wall. The piles for this project were driven 21'-23' to rock. Full elevation recovery was achieved.
